## Apartment Block

City of Andoain, SPAIN

Surface: White Carrara Marble

Product: STAIN-PROOF™

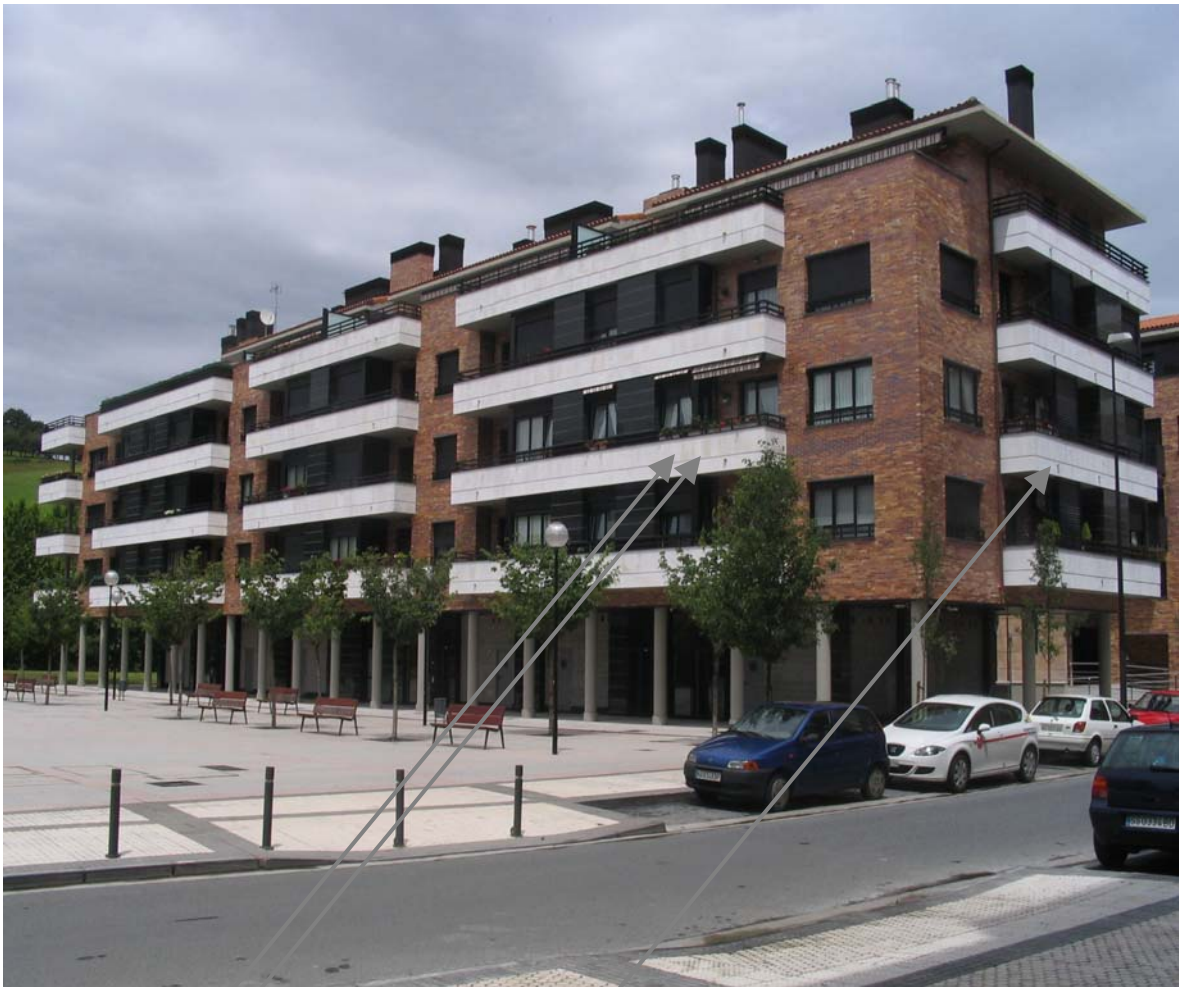
- 2) The water traveling through the marble was causing pyrite (iron) deposits within the marble to oxidize (rust) and stain the marble.

Oxidation stains. Water circulating inside the marble was causing microscopic metal deposits within the stone to rust. The rust coloured water was then circulating through the material and running down the outside, leaving these brown vertical marks behind

Dry-Treat STAIN-PROOF™ was applied to the marble, to create a deep water and oil repellent barrier within the marble. Only Dry-Treat's unique impregnating sealers are able to penetrate deep enough to prevent both entry of water into the marble and circulation of water through the material. STAIN-PROOF™ also forms a permanent chemical bond within the material without changing the colour or breathability of the material.

To date there have been no reports of further oxidation and the dampness in the apartments has dissipated. The STAIN-PROOF™ barrier has successfully prevented water from traveling from outside to inside through the porous marble and structural materials.
