# gan rise protective

Centre in Sydney  
tall among the con-  
ite of city skyscrap-  
maintenance works  
the structure re-  
protected into the

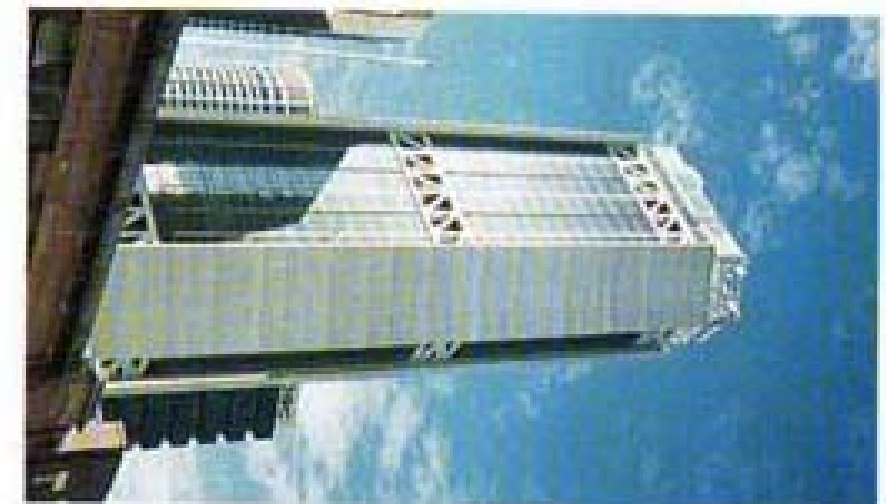
The assessments of the concrete  
in the six metre high trusses re-  
vealed it was in good condition.  
However, it was considered that,  
because of the unique and complex  
construction of the trusses, water  
penetration should be avoided.

for a solution and the company recommended the  
application of Dry-Treat 100N, a pure alkyl silane.

The product works by impregnating the concrete  
rather than acting as a coating. It provides long  
term protection against moisture ingress and the  
associated risk of rusting or corrosion of steel

Remedial Engineering carried out  
of Dry-Treat 100N. The product was  
despite difficult access and weather  
Surfaces to be treated were first  
water cleaned to ensure even abs  
chemical. The depth of uniform  
achieved was greater than 4.5mm g  
ment long-term protection against w
