Case Study

MEXICO
Carlos A. Parra,
Xpert Stone

Stone/Tile: Mexican Cantera and Saltillo

Product: STAIN-PROOF™ and ENHANCE PLUS™

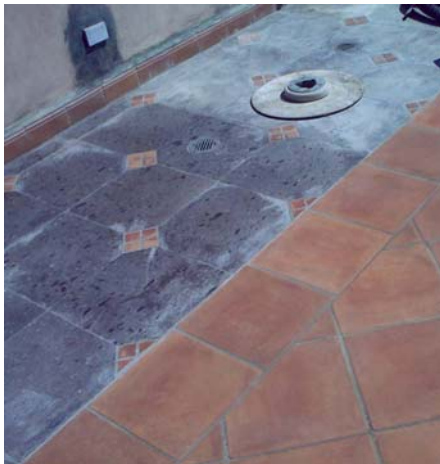
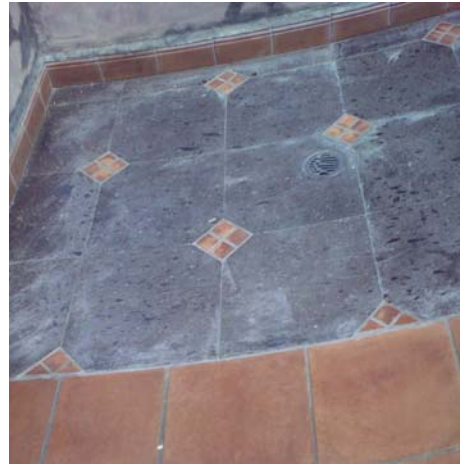
The project required the rejuvenation and sealing of the highly porous Mexican Cantera and Saltillo tiles at a beach front property in Mexico. The Mexican Cantera and Saltillo tiles were faded with signs of salt-efflorescence over the entire area. The salt-efflorescence was caused by water being able to move freely through the material. Water carries dissolved minerals which can be deposited on the surface when the water evaporates, leaving visible white patches.

White patches of salt-efflorescence and faded appearance of surface:

Xpert Stone specialist sealing expertise removed the existing staining and salt-efflorescence, before applying two coats of ENHANCE-PLUS™ to rejuvenate the faded appearance of the surface. Once the desired appearance was achieved the surface was left to cure for 24 hours. After the surface was completely cured, two coats of STAIN-PROOF™ were applied over the surface. By creating a deep dry barrier, STAIN-PROOF™ will continue to protect against future salt efflorescence and staining, whilst ENHANCE-PLUS™ will provide long lasting colour enrichment of the Cantera and Saltillo tiles.
